NBSIR 75-743 (R)

# Examination of Failed 3/4 Inch Steel Pipe Natural Gas Service Line, Sierra Pacific Power Company, Reno, Nevada

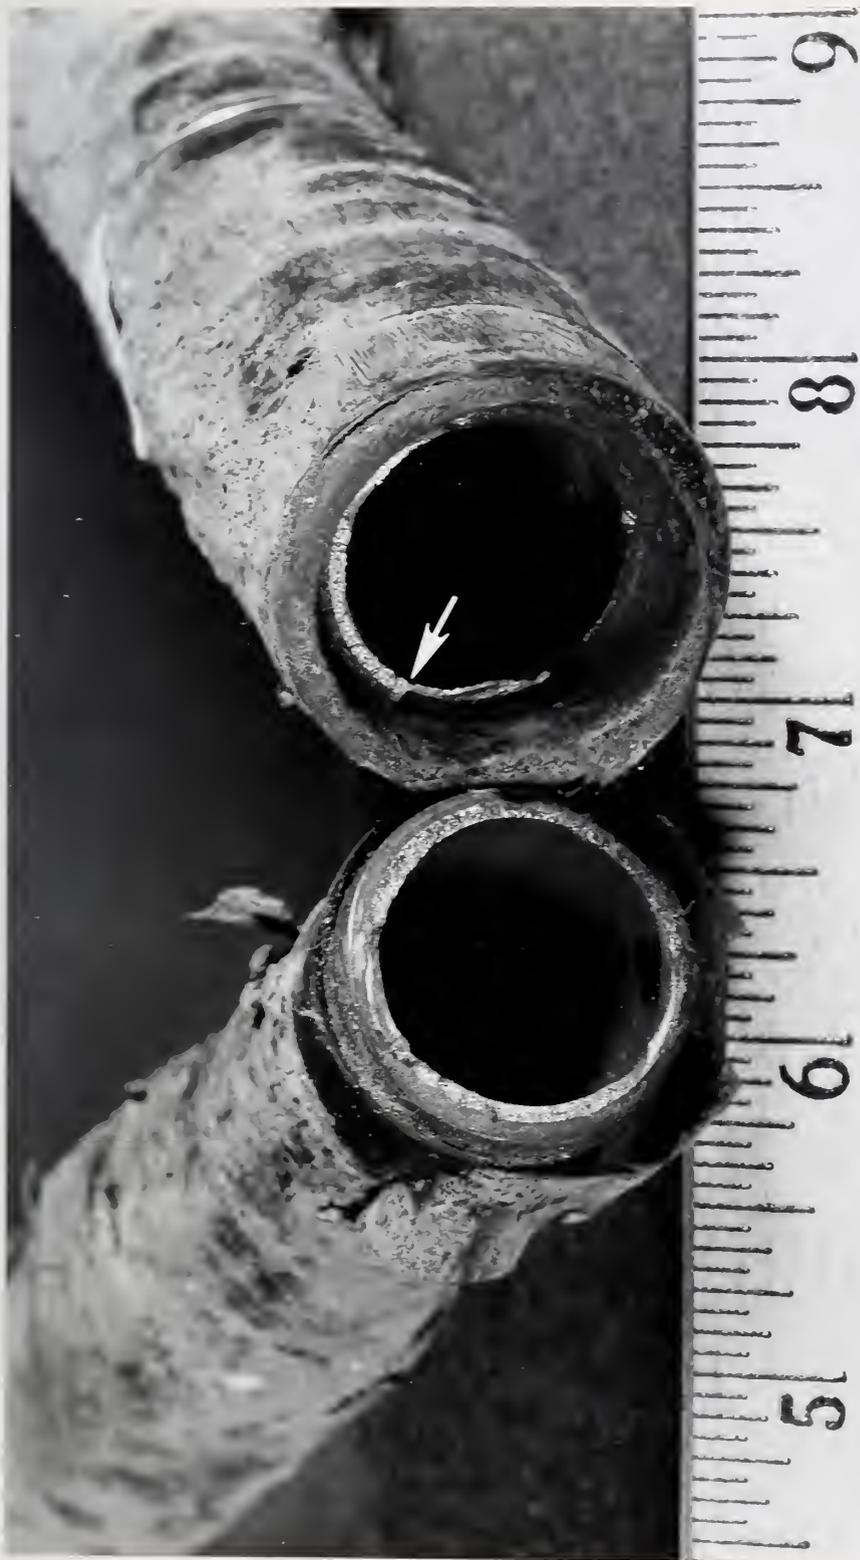
Figure 2. The two opposing fracture surfaces of the pipe as received at NBS. Piece "B" is at the left and piece "A" is at the right. Arrow indicates step in the fracture. The smallest division of the scale equals  $1/16$  inch.

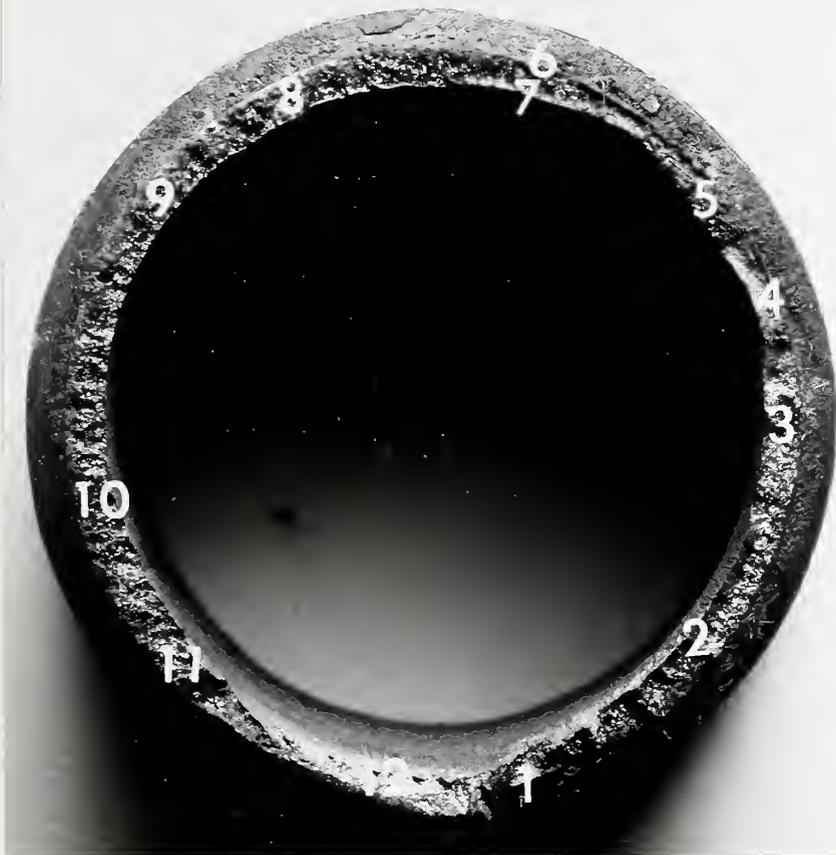
Figure 3. The fracture surface from the part of piece "B" which was not attached to the coupling. The step in the fracture (where the fracture path jumped a thread) is at the bottom. The numbers 1 through 12 represent areas referred to in the Section on the Fractographic Examination. X 4

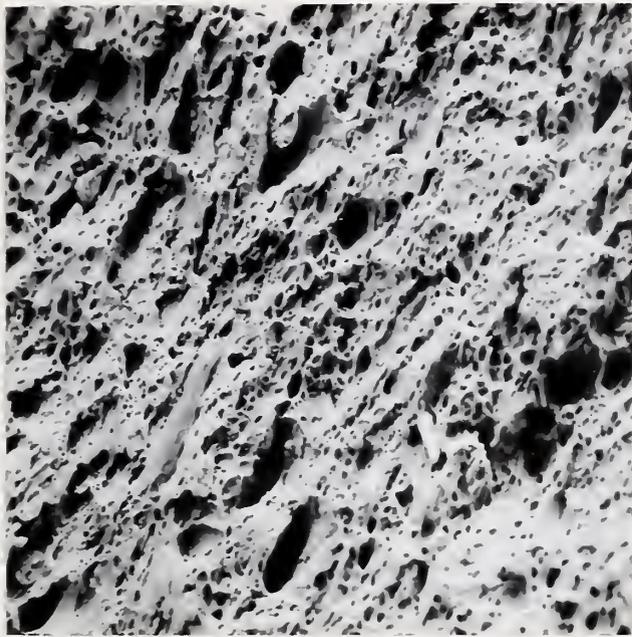
Figure 4. SEM fractograph from area 1, figure 3. The primary fracture mode is dimpled rupture. X 235

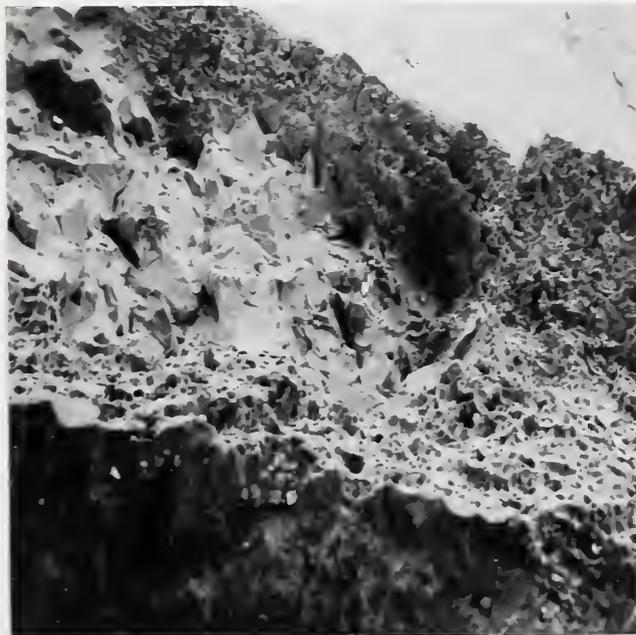
Figure 5. SEM fractograph from area 5, figure 3. The fracture mode is mixed with dimpled rupture adjacent to the inside and outside wall surfaces at the left and all the way across at the right. Quasi-cleavage appears in the center at the left. The inside wall surface is at the bottom. X 78

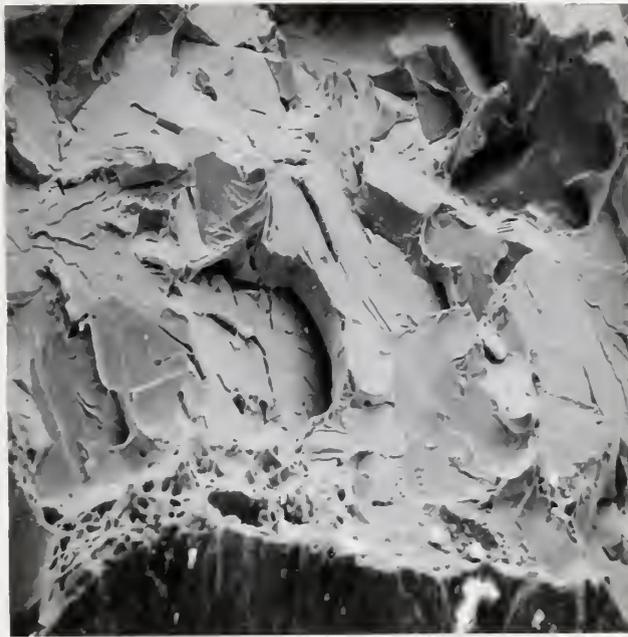
Figure 6. SEM fractograph from area 7, figure 3. The primary fracture mode is quasi-cleavage. There is some dimpled rupture near the inside wall. X 420

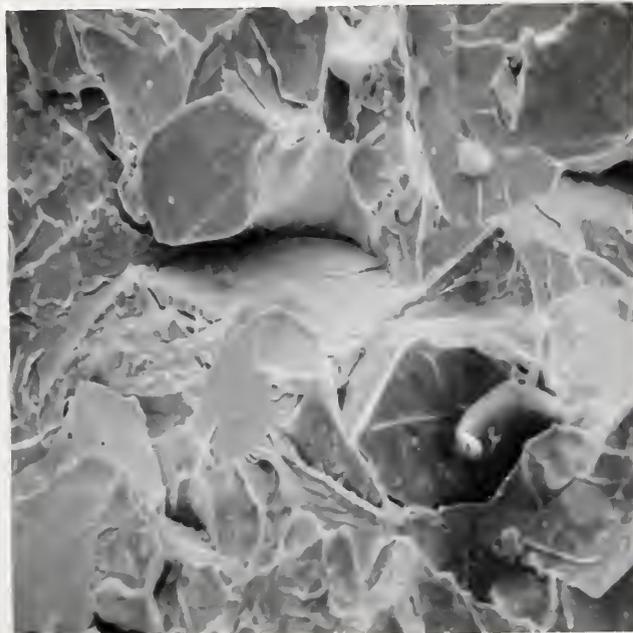
Figure 7. SEM fractograph from area 9, figure 3. The fracture mode is essentially all quasi-cleavage. X 475

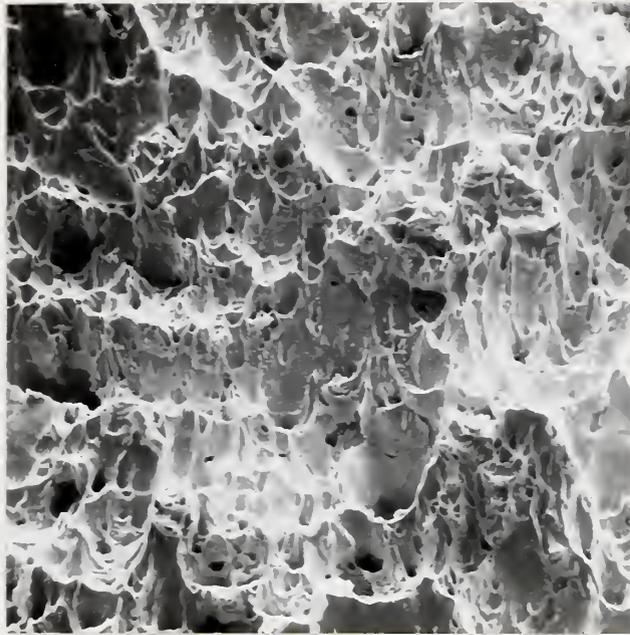
Figure 8. SEM fractograph from the tensile fracture produced in the laboratory at a machine cross head rate of 0.02 inch per minute. The mode of fracture is essentially all dimpled rupture. X 280

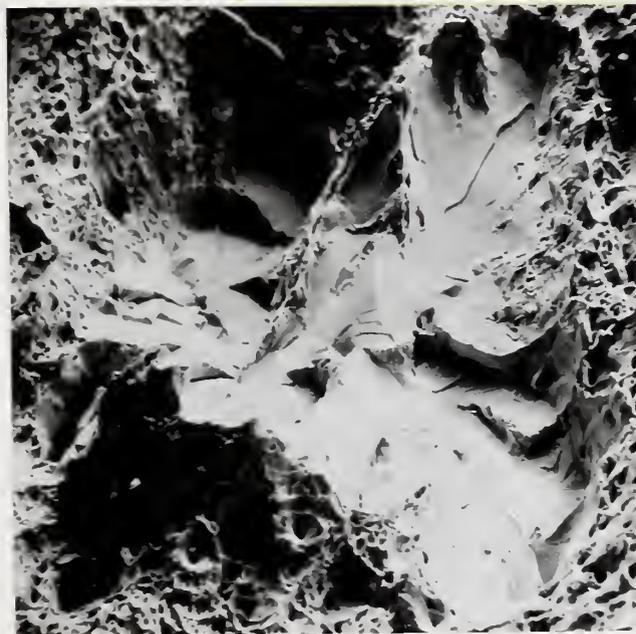
Figure 9. SEM fractograph from the tensile fracture produced in the laboratory at a machine cross head rate of 0.02 inch per minute. The mode of fracture in the center is quasi-cleavage. Around the periphery, the mode is primarily dimpled rupture. X 215

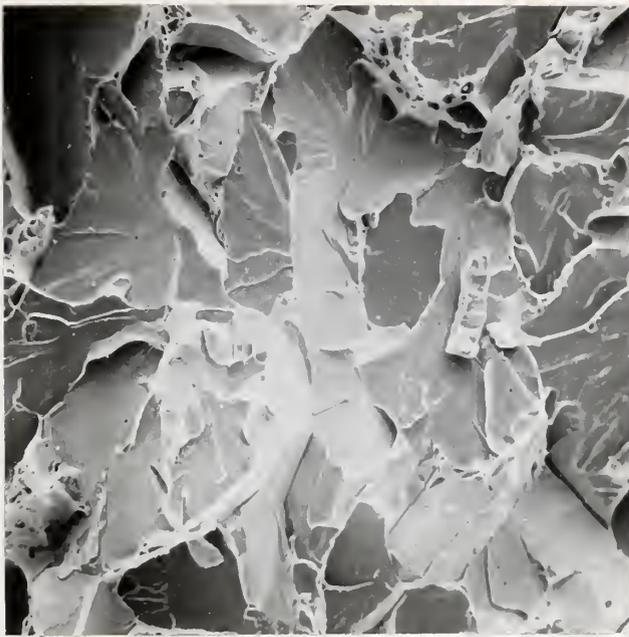
Figure 10. SEM fractograph from the tensile fracture produced in the laboratory at a machine cross head rate of 16 inches per minute. The mode of fracture in this region is primarily quasi-cleavage. There is a small amount of dimpled rupture. X 260

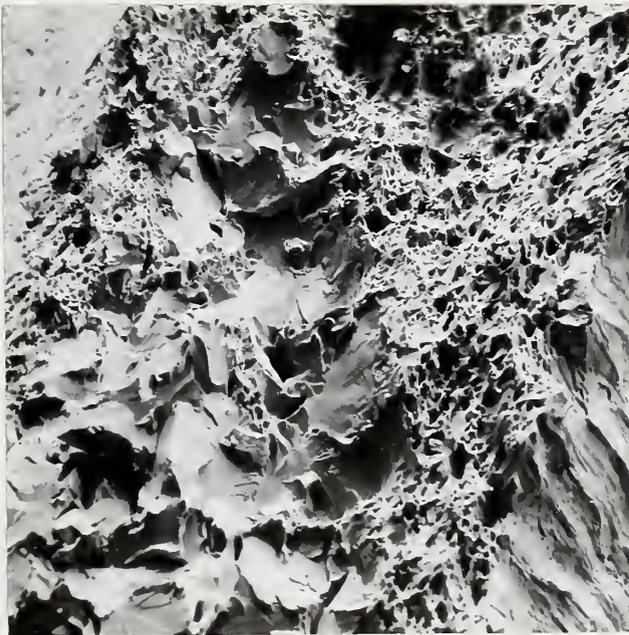
Figure 11. SEM fractograph from the tensile fracture produced in the laboratory at a machine cross head rate of 16 inches per minute. The fracture mode is mixed; there is about half dimpled rupture and half quasi-cleavage in this field. X 105

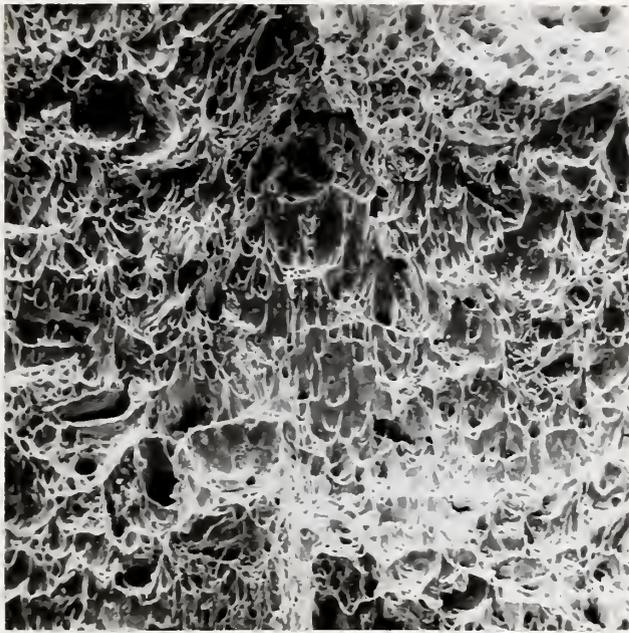
Figure 12. SEM fractograph from the tensile fracture produced in the laboratory at a machine cross head rate of 16 inches per minute. The fracture mode is primarily dimpled rupture. X 290

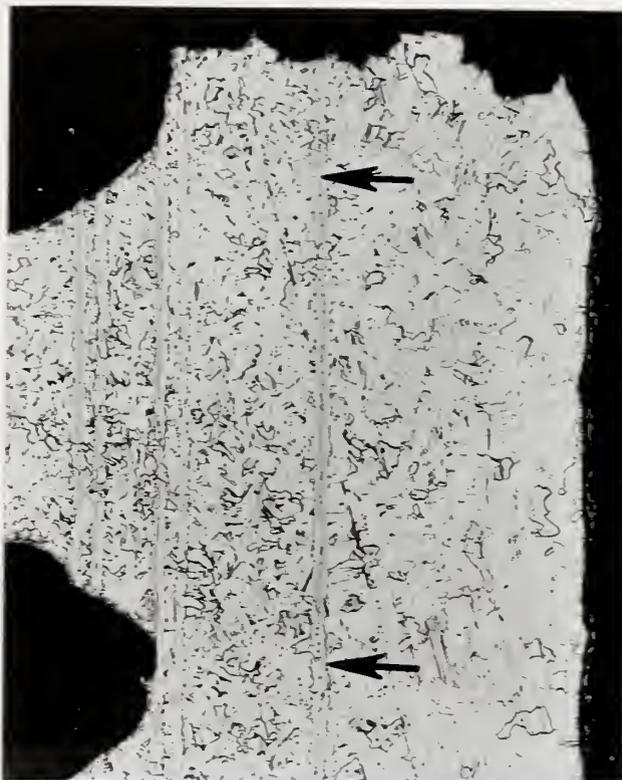
Figure 15. Etched longitudinal section intersecting the fracture at location 6, figure 3. The fracture profile is horizontal at the top. The microstructure consists of ferrite and pearlite except in the narrow bands which consist of ferrite. An example of one of the narrow bands is indicated by the arrows. The inside wall is vertical at the right and the threads are at the left. Etchant: 1% nital X 40

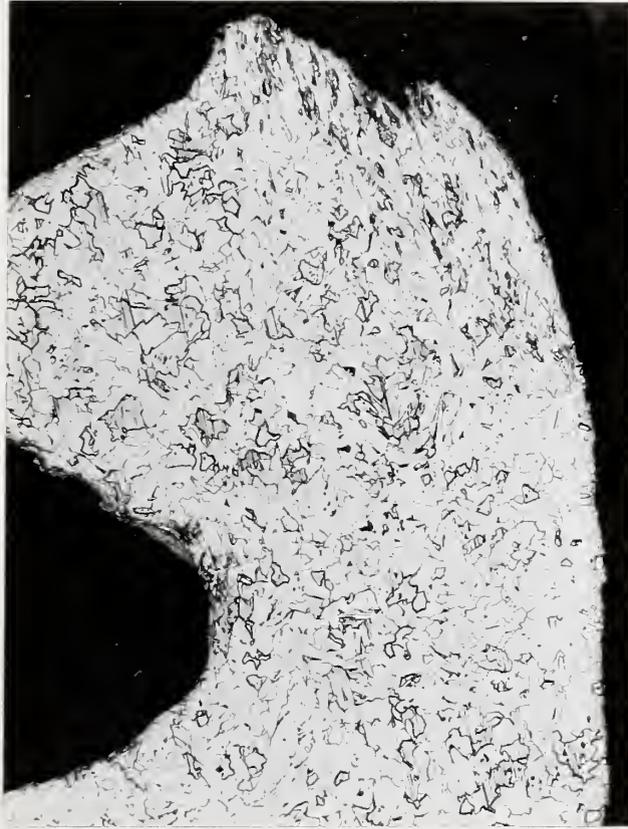
Figure 16. Etched longitudinal section intersecting the fracture at location 12, figure 3. The fracture profile is horizontal at the top. The microstructure consists of ferrite and pearlite. Distorted grains are evidence of deformation adjacent to the fracture. The inside wall is vertical at the right and the threads are at the left.
